Air permeability
Watertightness - static/dynamic
Resistance to wind load

Test Report

No. **11-000026-PR01**
(PB-B01-02-en-01)

Client	Institute IGH d.d. Janka Rakuse 1, 1000 - Zagreb Kroatien
Product	Double skin façade
System	SKY ED 105 BS
Construction project ¹⁾	Sky Office Zagreb
Overall dimensions (W x H)	2,881 mm x 5,006 mm
Frame material	Aluminium profiles with thermal break

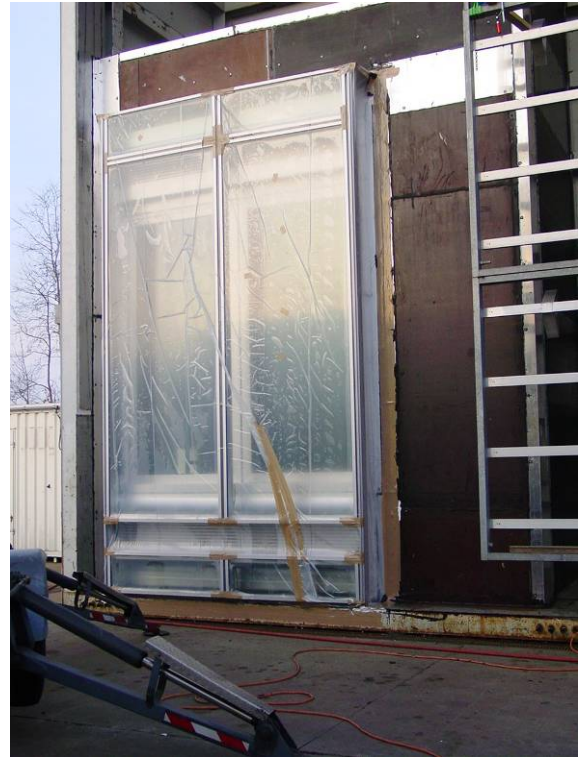
Fig. 2 Façade with film suspended in front for zero measurement

Prior to testing, the mounted facade element was covered with a film to eliminate all leakages on the facade. The leakages of the test rig system were determined by zero measurement. Thereafter the film was removed three pressure pulses with 660 Pa were applied to the facade and released as set out by the standard, followed by air permeability measurements. Air permeability was tested at up to a test pressure differential of 600 Pa. Measured values are listed in test record, Annex 2, page 1 and page 2. The values were obtained by the difference method, where the measured air permeability obtained from zero measurement is deducted from the air permeability of the facade.

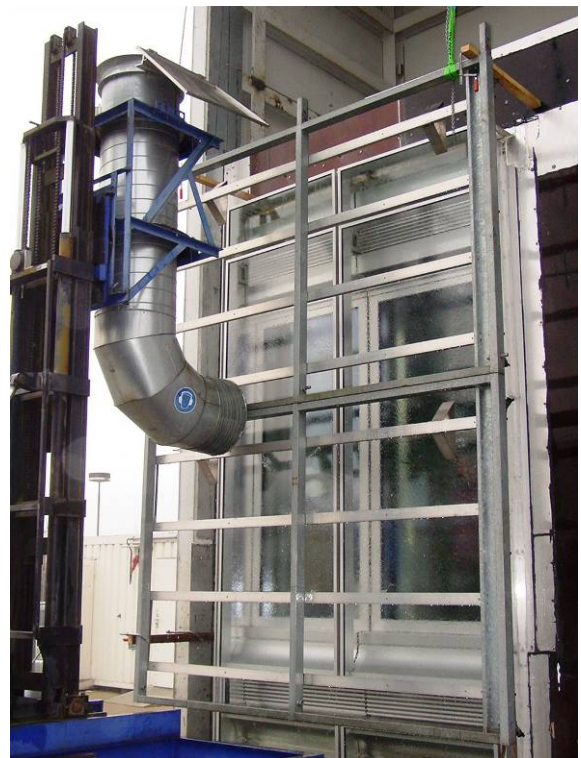
Fig. 4 Dynamic watertightness test

Using a movable wind generator located at approx. 65 cm distance from the test specimen, all areas of the facade are exposed to a regulated turbulent air flow and simultaneously to a water spray operation at a rate of 2 l/min m². The velocity of the air flow at a distance of approx. 20 mm from the end of the air channel is approx. 20 m/sec. At the same time, negative pressures alternating between - 221 Pa / - 662 Pa every 5 ± 1 sec. are generated in the test chamber. The time required by the test to cover all joints was approx. 20 minutes. No water penetration was detected.

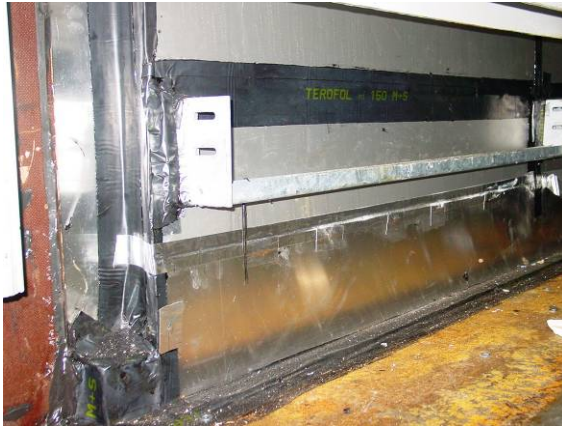
Fig. 17 Coupling joints internally masked with sealing membrane Terofol (M+S) vapour tight

Coupling joints internally masked with self-adhesive sealing membrane Terofol (M+S) vapour tight

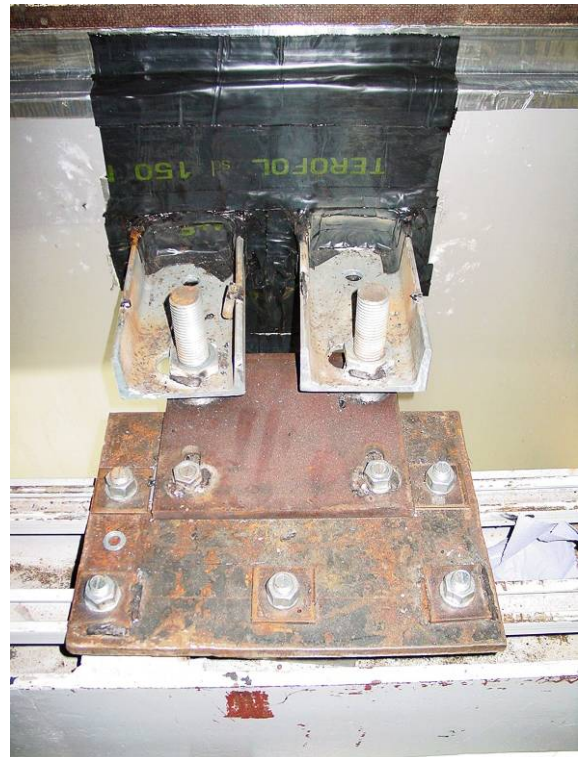
Fig. 20 Fixing brackets internally masked with sealing membrane Terofol (M+S) vapour tight

Type, see Annex 1, Fig. 20

Facade brackets continuously masked around perimeter with self-adhesive sealing membrane Terofol (M+S) vapour tight

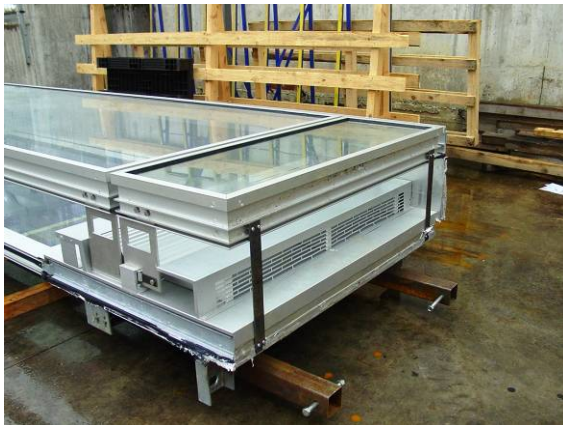
Fig. 29 Fixing of secondary facade

internal	Glazing gasket, Item No. ZMB 003 (7 mm), EPDM, mitred and bonded
Vapour pressure equalisation	2 slots of 5 x15 mm downwards, in glazing bead of each unit
Unit gaskets	
Horizontal	Internal: coupling gasket Item No. ZMB 021, EPDM
Corner design	Internal: butt-jointed to vertical coupling gasket, ends not sealed with elastic sealant and secured against slipping.
Vertical	Internal: glazing gasket Item No. ZMB 021, EPDM continuous, ends not secured against slipping
Corner design	Internal: vertical coupling gasket Item No. ZMB 021, EPDM continuous, ends not secured against slipping
Fixing brackets	Type, see Annex 1 , Fig. 29

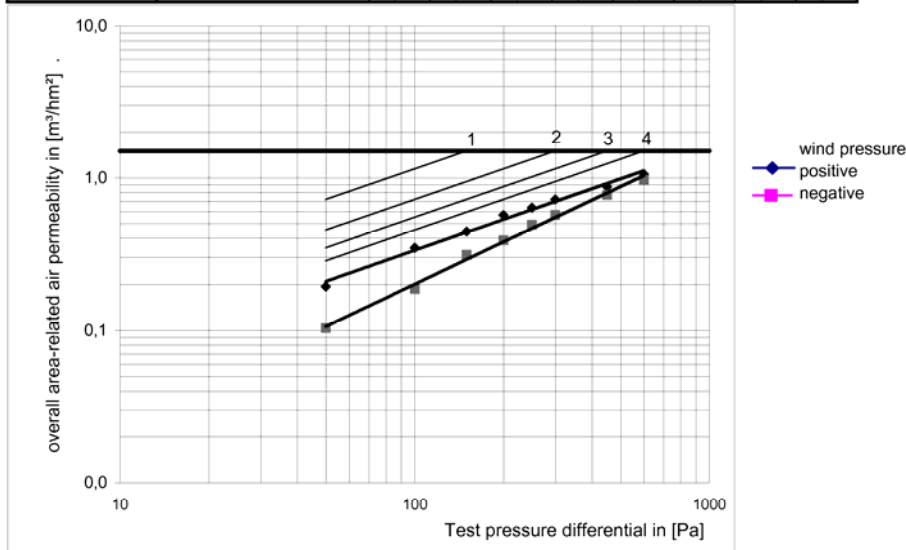
Diagram Overall area-related air permeability

Air permeability of fixed elements at max. positive test pressure, overall area-related	$Q_{f,A} = 1,05 \text{ m}^2/(\text{hm}^2)$
Maximum test pressure, positive (overall area-related)	$P_{\text{max}} = 600 \text{ Pa}$
Air permeability of fixed elements at max. negative test pressure, overall area-related	$Q_{f,A} = 0,97 \text{ m}^2/(\text{hm}^2)$
Maximum test pressure, negativ (overall area-related)	$P_{\text{max}} = 600 \text{ Pa}$

The values obtained were below the limit curve for class A4 at a test pressure differential of 600 Pa below the maximum permissible air permeability of $1.5 \text{ m}^3/(\text{h m}^2)$, related to the overall area of the curtain walling. Reference to the joint length of fixed joints was not possible, because most joints in the opaque area were masked with self-adhesive sealing membrane Terofol (M+S) vapour tight.
